HIGHRISE FIRES

The following pictures are from a recent highrise fire in the Bronx, New York. The fire originated in the bedroom of a residential highrise unit on the 24th floor then erupted into a fast moving three-alarm fire involving two floors, multiple companies, maydays with missing firefighters and a number of priority messages. High wind conditions and auto-exposure were the primary factors that changed the intensity of this basic room and contents fire into a three-alarm blaze.

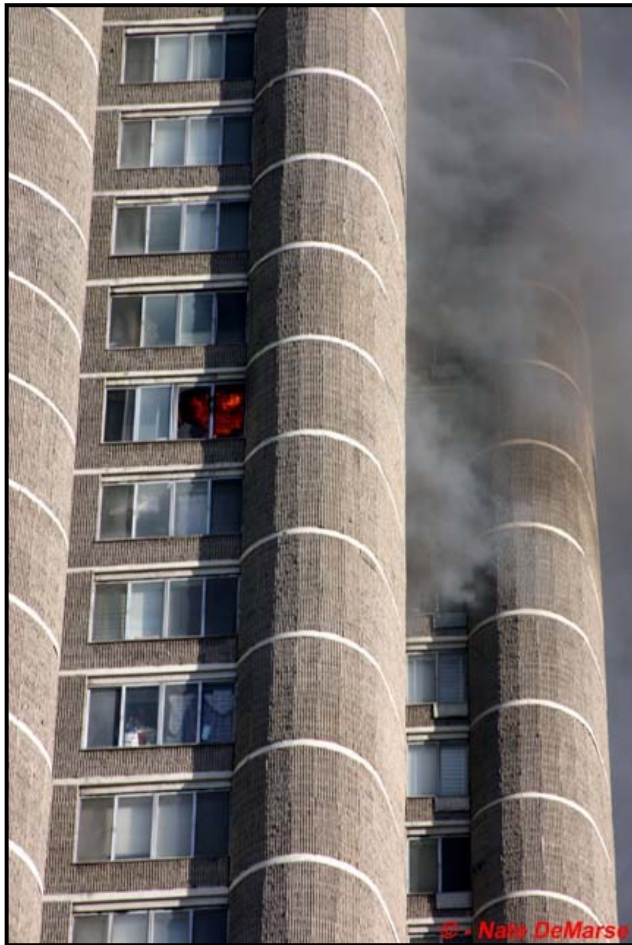
The windows fail on the windward side of the building. Note the fire in the window but NO SMOKE OR FIRE coming out of the window. This indicates two things.

- 1) An open hallway door (meaning the fire has some place else to vent other than out the window)**
- 2) A severe wind condition is keeping the fire in the building**

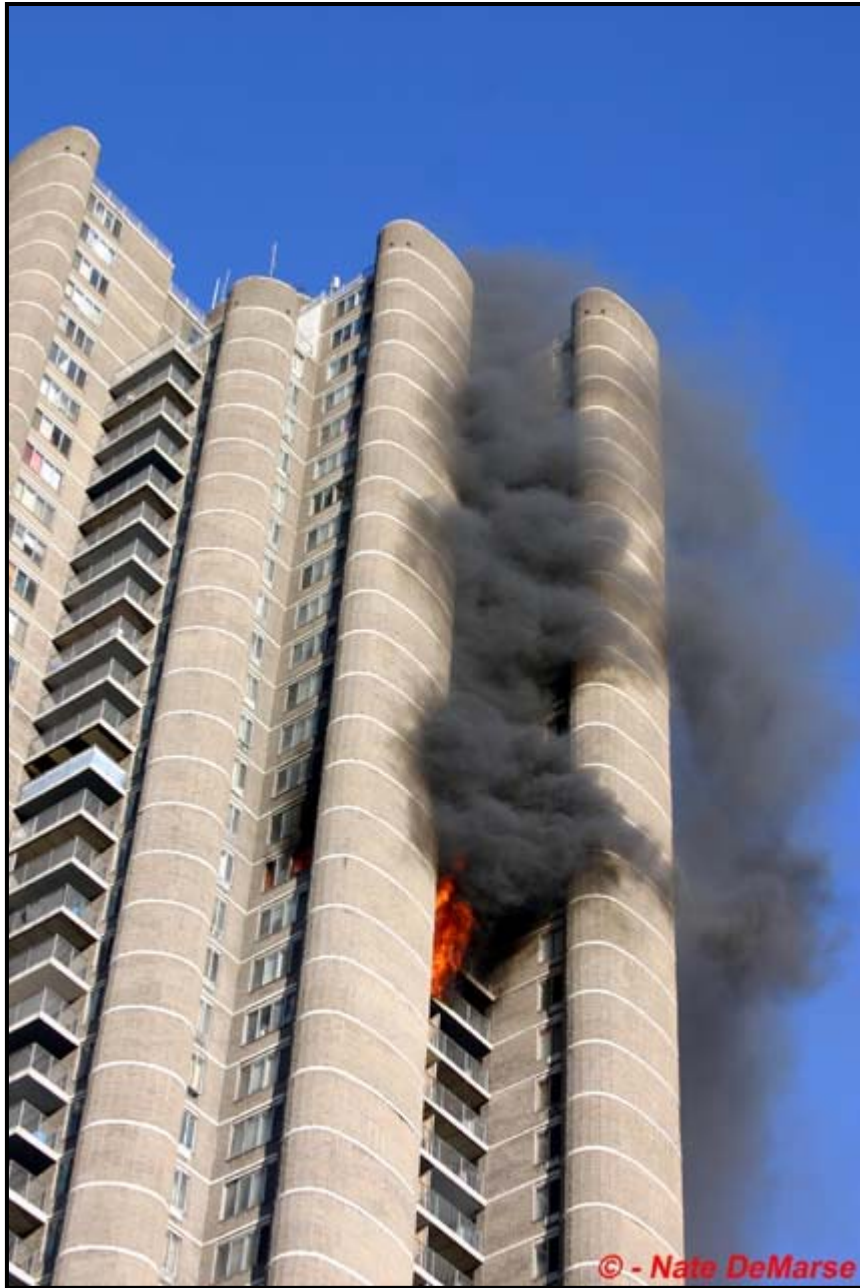
At this point, companies are backing out to the public hallway. Control of the fire door was maintained (VERY IMPORTANT) and kept closed. A 2nd line (2 1/2") was requested to be stretched next to the 1st line so they could be advanced side-by-side.

Also, the fire was extending via auto-exposure into the 25th floor as companies were calling for lines. Eventually companies were driven out of that apartment and into the public hallway. Several maydays were transmitted as well as several urgent messages.

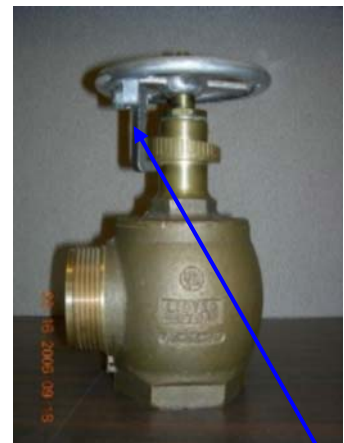
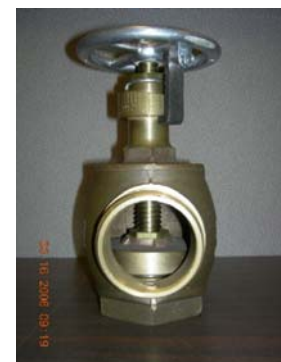
3. Check the stand pipe risers for PRV's (pressure regulating or reducing valves); the presences of these valves can significantly reduce water flow through stand pipe discharges if they are improperly set. Generally, they can be found in some of our taller buildings in Montgomery County. They are used to reduce high pressures at the base of a stand pipe riser generated by fire pumps supplying upper floors. Some valves are designed to be removable where others are installed in-line with the piping and may be overridden or field adjusted. There are those that are not adjustable at all. Either configuration can hinder flows from automatic fog nozzles requiring 100 psi discharge pressures (***consider an alternate 2"1/2 stand pipe pack with a smoothbore nozzle for confirmed working fires or use the slug tip of a break away nozzle or low pressure fog nozzle in your existing stand pipe pack***). If found in existing buildings, contact Code Enforcement immediately.

This stem
can be field
adjusted

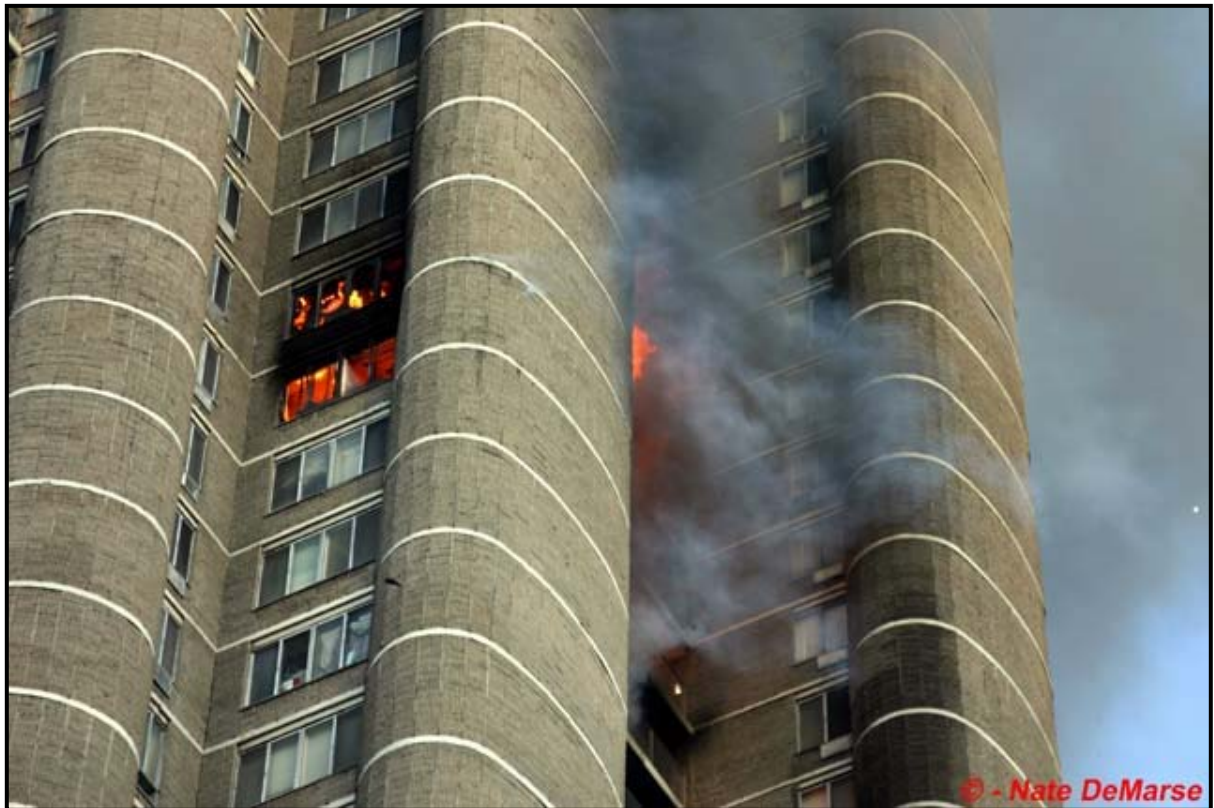
Heavy smoke and fire are now venting out of the 24th & 25th floors. These shots were taken 10 minutes after the previous shots. NOTE THAT ON THE RIGHT SET OF WINDOWS, the fire is being driven into the apartment by the wind. There is no smoke coming out of the right windows at all.
